## Corridor-Wide Roadway Safety Analysis with RSA 3D

RDV Systems used its RSA 3D platform to conduct a comprehensive roadway safety analysis along Telegraph Road in Stafford County, Virginia. Using LiDAR, high-resolution imagery, and automated analytics, the study evaluated stopping sight distance (SSD), passing sight distance (PSD), intersection sight distance (ISD), horizontal curve geometry, safe speeds, and roadside clear-zone conditions. The analysis identified potential sight-distance, geometric, and roadside hazards to support targeted engineering review and proactive safety improvements.

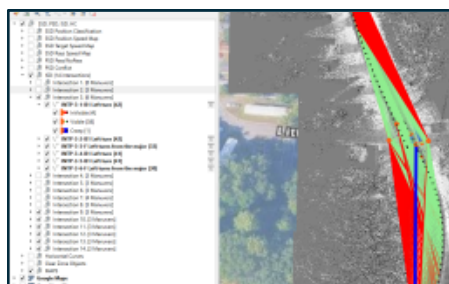
**INTERSECTION SIGHT DISTANCE**

3D visibility analysis

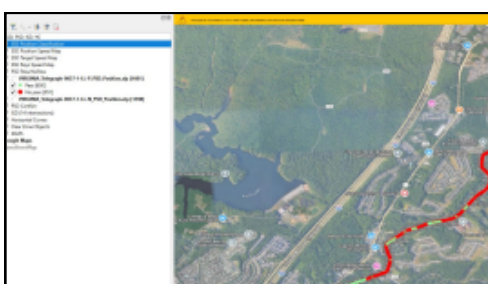
**PASSING SIGHT DISTANCE**

Pass / No Pass Analysis

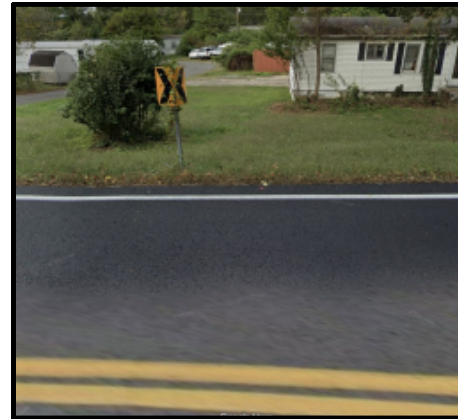
### FIELD VERIFICATION

Roadside signage and vegetation conditions
